SRF Consulting Group, Inc.

SRF No. 8060: Hwy 5
Location: Hwy 101/ 78th St
Weekday Count
SRF Consulting

File Name : 130_Hwy 101 & 78th St
Site Code : 09281120
Start Date : 2/13/2013
Page No : 1

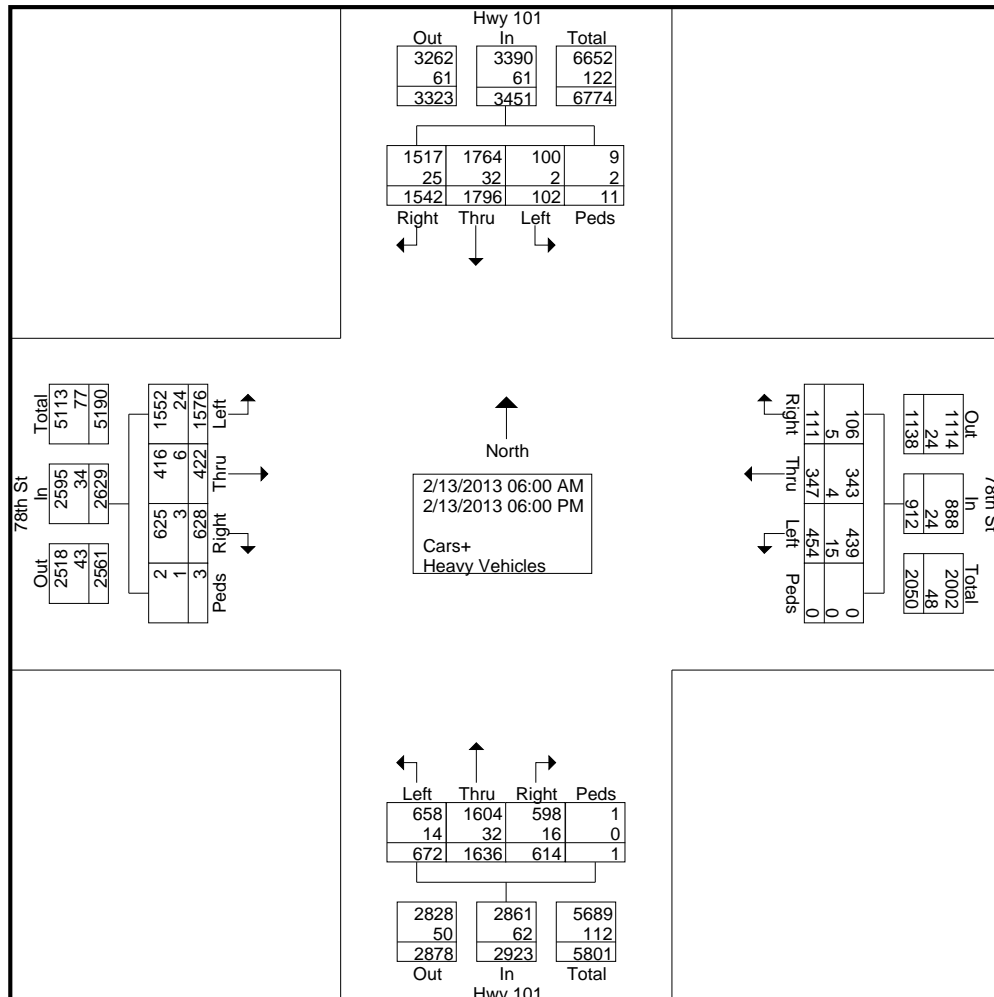
Grand Total	11	102	1796	1542	3451	0	454	347	111	912	1	672	1636	614	2923	3	1576	422	628	2629	9915
Apprch %	0.3	3	52	44.7		0	49.8	38	12.2		0	23	56	21		0.1	59.9	16.1	23.9		
Total %	0.1	1	18.1	15.6	34.8	0	4.6	3.5	1.1	9.2	0	6.8	16.5	6.2	29.5	0	15.9	4.3	6.3	26.5	
Cars+	9	100	1764	1517	3390	0	439	343	106	888	1	658	1604	598	2861	2	1552	416	625	2595	9734
% Cars+	81.8	98	98.2	98.4	98.2	0	96.7	98.8	95.5	97.4	100	97.9	98	97.4	97.9	66.7	98.5	98.6	99.5	98.7	98.2
Heavy Vehicles	2	2	32	25	61	0	15	4	5	24	0	14	32	16	62	1	24	6	3	34	181
% Heavy Vehicles	18.2	2	1.8	1.6	1.8	0	3.3	1.2	4.5	2.6	0	2.1	2	2.6	2.1	33.3	1.5	1.4	0.5	1.3	1.8

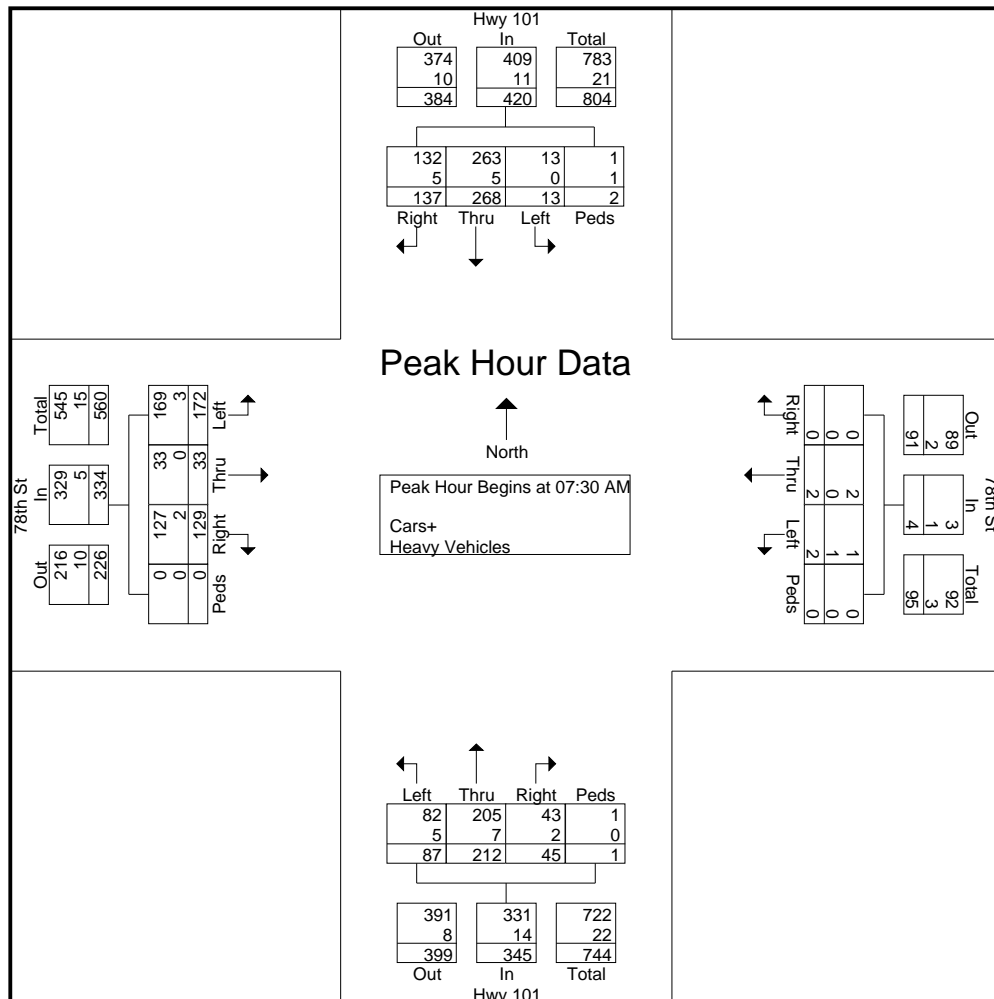
Start Time	Hwy 101 Southbound					78th St Westbound					Hwy 101 Northbound					78th St Eastbound					Int. Total
	Peds	Left	Thru	Right	App. Total	Peds	Left	Thru	Right	App. Total	Peds	Left	Thru	Right	App. Total	Peds	Left	Thru	Right	App. Total	
Peak Hour Analysis From 06:00 AM to 08:45 AM - Peak 1 of 1																					
Peak Hour for Entire Intersection Begins at 07:30 AM

08:15 AM	0	2	67	32	101	0	1	0	0	1	1	28	60	5	94	0	38	5	41	84	280
Total Volume	2	13	268	137	420	0	2	2	0	4	1	87	212	45	345	0	172	33	129	334	1103
% App. Total	0.5	3.1	63.8	32.6		0	50	50	0		0.3	25.2	61.4	13		0	51.5	9.9	38.6		
PHF	.500	.542	.779	.835	.868	.000	.500	.500	.000	.500	.250	.702	.883	.662	.918	.000	.843	.516	.787	.827	.890
Cars+	1	13	263	132	409	0	1	2	0	3	1	82	205	43	331	0	169	33	127	329	1072
% Cars+	50.0	100	98.1	96.4	97.4	0	50.0	100	0	75.0	100	94.3	96.7	95.6	95.9	0	98.3	100	98.4	98.5	97.2
Heavy Vehicles																					
% Heavy Vehicles	50.0	0	1.9	3.6	2.6	0	50.0	0	0	25.0	0	5.7	3.3	4.4	4.1	0	1.7	0	1.6	1.5	2.8

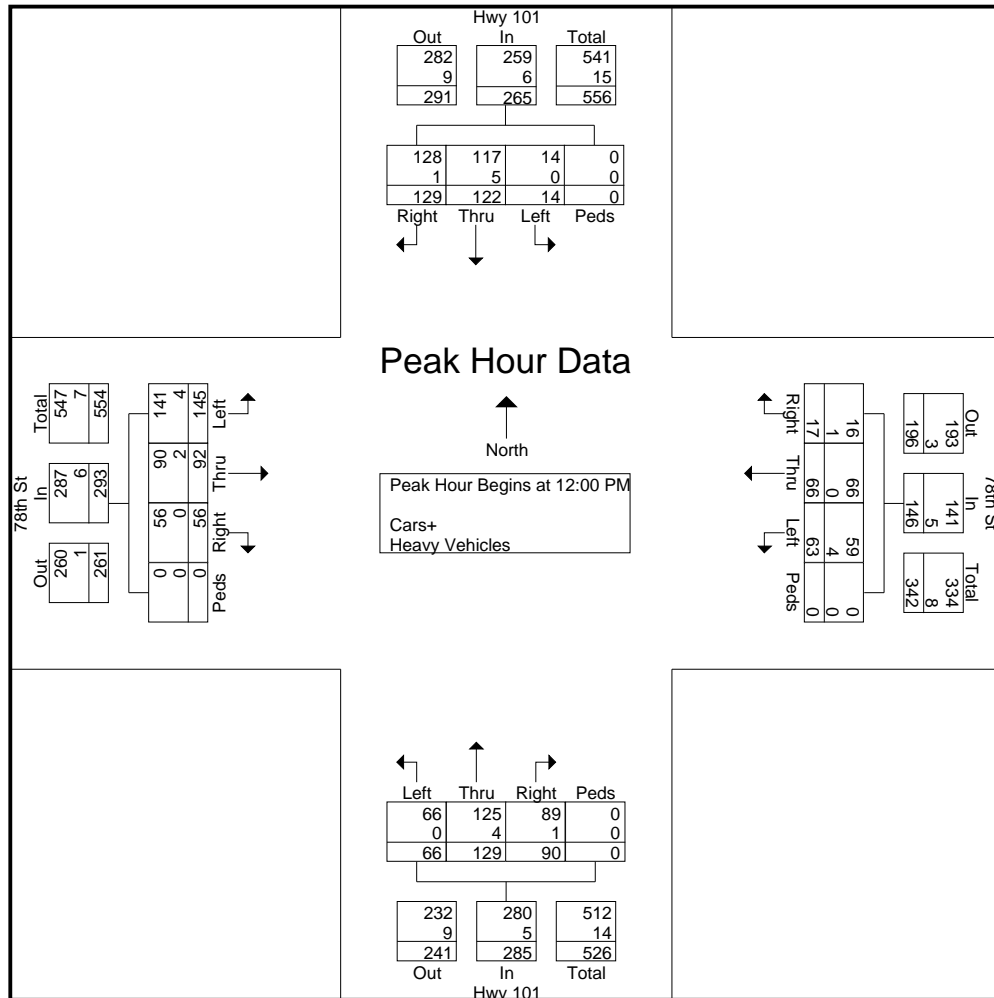
Start Time	Hwy 101 Southbound					78th St Westbound					Hwy 101 Northbound					78th St Eastbound					Int. Total
	Peds	Left	Thru	Right	App. Total	Peds	Left	Thru	Right	App. Total	Peds	Left	Thru	Right	App. Total	Peds	Left	Thru	Right	App. Total	
Peak Hour Analysis From 09:00 AM to 12:45 PM - Peak 1 of 1																					
Peak Hour for Entire Intersection Begins at 12:00 PM

12:45 PM	0	3	39	33	75	0	17	17	4	38	0	18	28	27	73	0	34	26	12	72	258
Total Volume	0	14	122	129	265	0	63	66	17	146	0	66	129	90	285	0	145	92	56	293	989
% App. Total	0	5.3	46	48.7		0	43.2	45.2	11.6		0	23.2	45.3	31.6		0	49.5	31.4	19.1		
PHF	.000	.583	.782	.921	.883	.000	.875	.688	.607	.869	.000	.917	.787	.833	.925	.000	.954	.885	.700	.904	.958
Cars+	0	14	117	128	259	0	59	66	16	141	0	66	125	89	280	0	141	90	56	287	967
% Cars+	0	100	95.9	99.2	97.7	0	93.7	100	94.1	96.6	0	100	96.9	98.9	98.2	0	97.2	97.8	100	98.0	97.8
Heavy Vehicles																					
% Heavy Vehicles	0	0	4.1	0.8	2.3	0	6.3	0	5.9	3.4	0	0	3.1	1.1	1.8	0	2.8	2.2	0	2.0	2.2

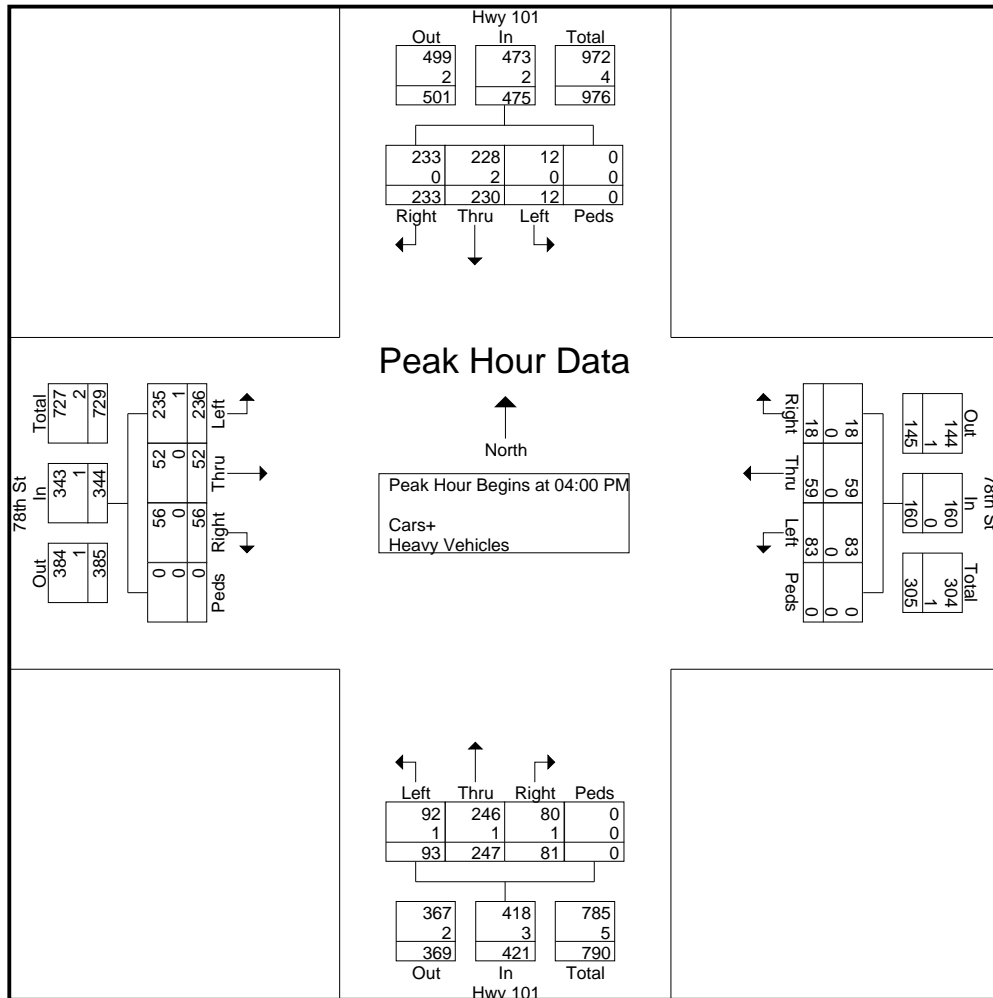
Start Time	Hwy 101 Southbound					78th St Westbound					Hwy 101 Northbound					78th St Eastbound					Int. Total
	Peds	Left	Thru	Right	App. Total	Peds	Left	Thru	Right	App. Total	Peds	Left	Thru	Right	App. Total	Peds	Left	Thru	Right	App. Total	
Peak Hour Analysis From 01:00 PM to 04:45 PM - Peak 1 of 1																					
Peak Hour for Entire Intersection Begins at 04:00 PM

04:45 PM	0	4	55	62	121	0	20	13	9	42	0	25	68	16	109	0	64	12	13	89	361
Total Volume	0	12	230	233	475	0	83	59	18	160	0	93	247	81	421	0	236	52	56	344	1400
% App. Total	0	2.5	48.4	49.1		0	51.9	36.9	11.2		0	22.1	58.7	19.2		0	68.6	15.1	16.3		
PHF	.000	.750	.927	.940	.935	.000	.943	.868	.500	.870	.000	.861	.908	.723	.948	.000	.868	.765	.824	.915	.970
Cars+	0	12	228	233	473	0	83	59	18	160	0	92	246	80	418	0	235	52	56	343	1394
% Cars+	0	100	99.1	100	99.6	0	100	100	100	100	0	98.9	99.6	98.8	99.3	0	99.6	100	100	99.7	99.6
Heavy Vehicles																					
% Heavy Vehicles	0	0	0.9	0	0.4	0	0	0	0	0	0	1.1	0.4	1.2	0.7	0	0.4	0	0	0.3	0.4
